GLASS UNLIMITED

## **Technical Information – 09/2010**

### **Risk of Nickel Sulfide presence in glass**

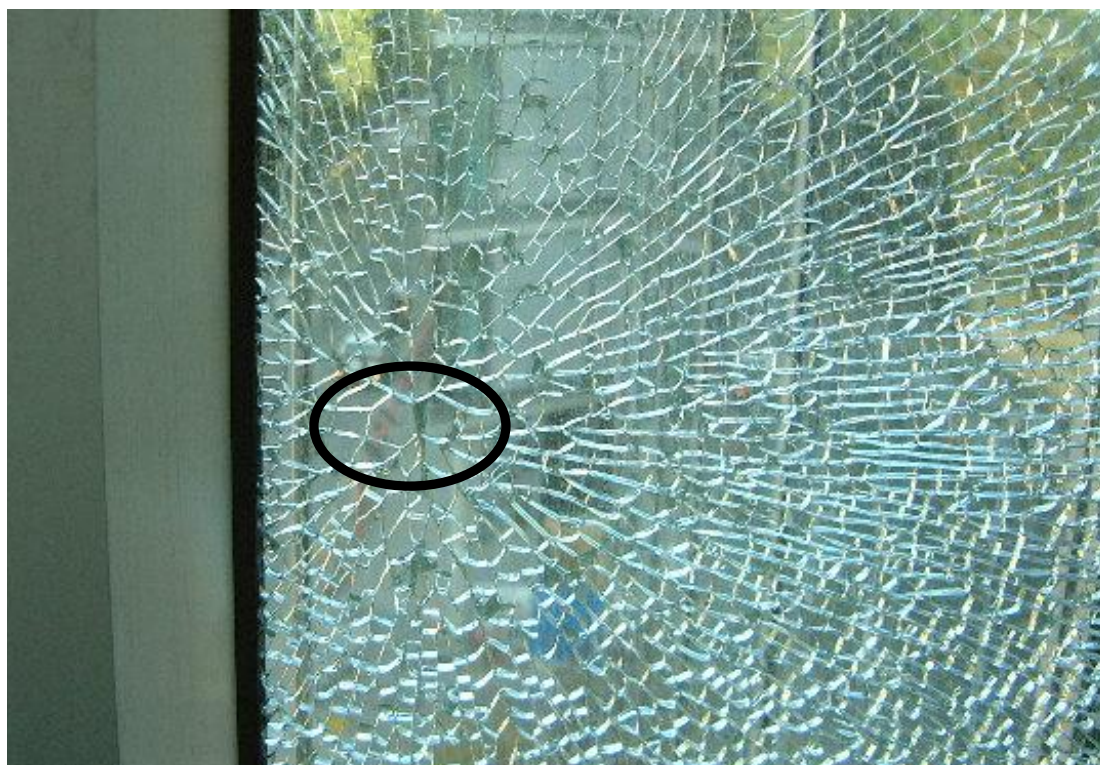
In this case, we find a characteristic breakage in the shape of butterfly. Many articles and publications exist on the subject. The phenomenon is inherent to thermally toughened glass, and can therefore not be considered a hidden defect of the product.

*Typical breakage starting from a NiS inclusion*

2°) If the thermally toughened glass is necessary, a process called “heat soak” can be achieved. This one consists in placing glass in a furnace at a stage of temperature, during a determined time, in order to enable and accelerate the transformation of NiS. The rupture due to the possible presence of critical particles of NiS will occur during this treatment.
